# A summary of ship strikes and the operation of a high speed ferry in Hawai'i

LYMAN<sup>1</sup>, EDWARD; DAVID K. MATTILA<sup>1</sup>, DAVID SCHOFIELD<sup>2</sup> AND JEFF WALTERS<sup>2</sup>

<sup>1</sup> NOAA, Hawaiian Islands Humpback Whale National Marine Sanctuary (HIHWNMS), 726 S. Kihei Road, Kihei, HI 96753 USA

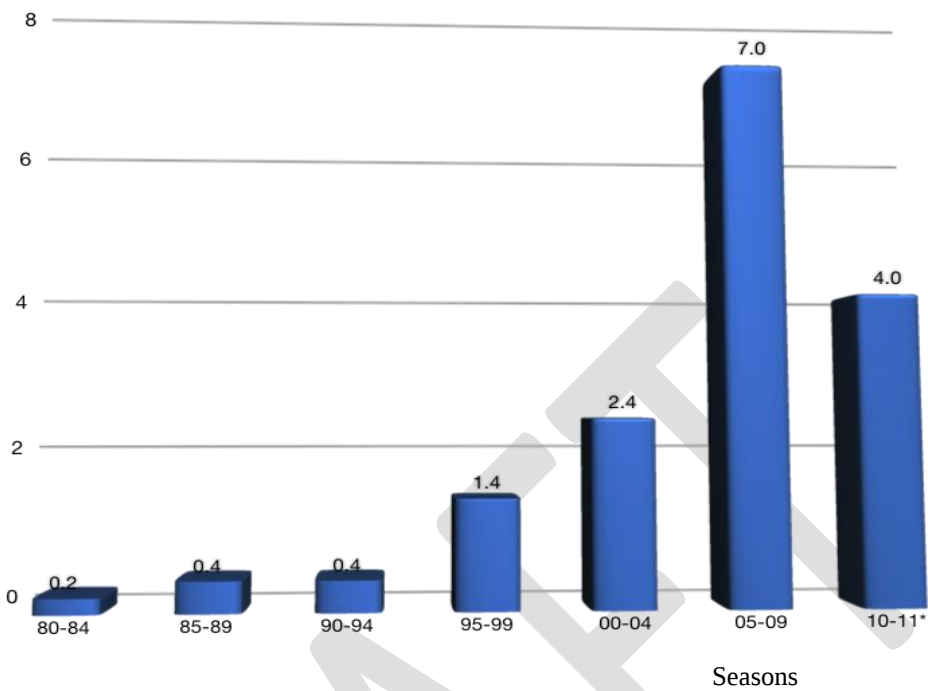
**Figure two.** Average number of whale strikes/year, in five-year bins

\* Represents annual average over just two seasons.

Since the 2003 workshop, NOAA and the State of Hawai'i have placed whale collision avoidance signage at most of Hawai'i's harbours, developed brochures and press releases, and conducted 14 to 18 targeted vessel operator seminars annually, highlighting whale collision avoidance. While it is difficult to know how much this educational effort improved reporting, the number of collision reports has increased noticeably during the period (2003-2011, Figure two). In their review, Lammers et al. (2003) provided a questionnaire to professional mariners that asked, amongst other questions, "what percentage of whale collisions that they were aware of were actually reported to authorities?" The majority estimated that only 25% of collisions were reported prior to 2003. Therefore, it is likely

that much of the increase in reporting after 2003 is a result of the increased awareness resulting from the education and outreach, along with more rigorous record keeping, as many of the early ship strike report in the Lammer's et al review were from newspaper archives. Evidence supporting this comes from the fact that most reports (83.3%, 35 of 42) since 2003 were self-reported. They were reported directly by the vessel operator at or near the time the strike occurred by use of the established Hotline or by contacting one of the mitigating agencies.

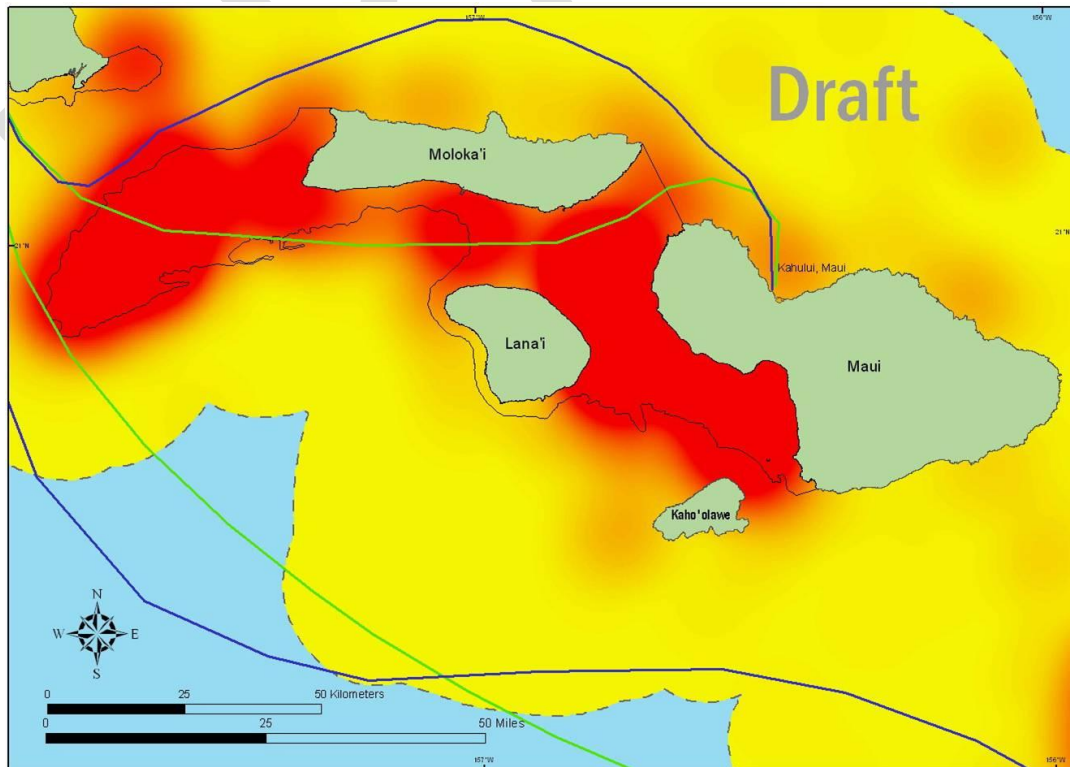
**Figure three.** Standard route through HIHWNMS and alternate route North of Molokai

The 105 m, high speed (35 kts), catamaran operated by "Hawai'i Superferry, Inc." was in operation in Hawaiian waters for only 11 months in 2007 and 2008, before it ceased operations, largely due to the ruling from the Supreme Court of Hawai'i, concerning its environmental impact. During these 11 months it only operated part of one humpback whale season (January and April of 2008). However, through a combination of both voluntary and mandated protocols (State of Hawai'i Executive order no. 07-10), the Superferry kept logbooks of its transits through Sanctuary waters, and any close (<91 m) encounters with whales. One significant mandate was for the Superferry to seek alternate routing (Figure three) and avoid transiting HIHWNMS waters during whale season (January 1 to April 30). Another was that it should decrease its speed to 25 kts if it did transit HIHWNMS waters, or other known humpback whale habitat (i.e. <183 m) during whale season. This speed was a compromise based on the speed of other vessels transiting whale habitat (i.e. up to 25 kts), and the purported manoeuvrability of the Superferry.

Unfortunately, the crew were only mandated to enter "positive" data (e.g. when the vessel transited the Sanctuary, or had a close encounter with a whale) into their logbooks and were not required to record all transits outside of the Sanctuary, nor days when they did not transit at all due to bad weather or logistical issues. And so it is impossible at this time to determine how successful they were at using alternate less risky routes. However, because the vessel always made roundtrips from Oahu to Maui (one leg) and back (a "second" leg), it is clear from the logbooks that the vessel was at least able to avoid transiting the Sanctuary on most of its return trips from Maui to Oahu where conditions tended to be consistently downwind with following seas. And so, on the twenty days that we can confirm from its whale logbooks that the Superferry operated during the 2008 whale season, it transited the Sanctuary during 19 legs of a possible 40 (2 legs x 20 days). This is an overestimate of the percentage of their trips that transited the Sanctuary, as it does not include days when they made both legs on the alternate route. During a "rapid" risk assessment, conducted by an independent consulting company (Belt Collins Hawai'i Ltd., 2008), the Superferry only transited the Sanctuary 4 of 20 one-way legs, during whale season. It is also clear from their logbooks that the Captain confirmed that the vessel did slow to 25 kts when within Sanctuary boundaries.
